St. Cloud Technical & Community College

MASTER FACILITY PLAN 2012

100% | 12.10.14

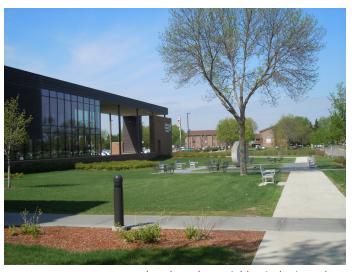
Landscaping outside student services

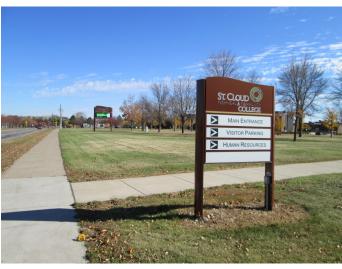
Wayfinding signage at northwest entrance to campus

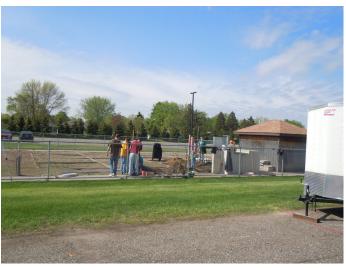
Plumbing & electrical classes' outdoor learning area

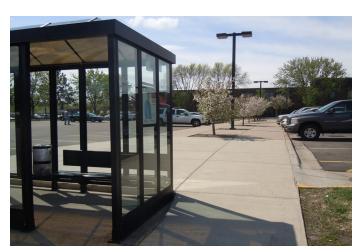
Bus shelter near MN Workforce Center

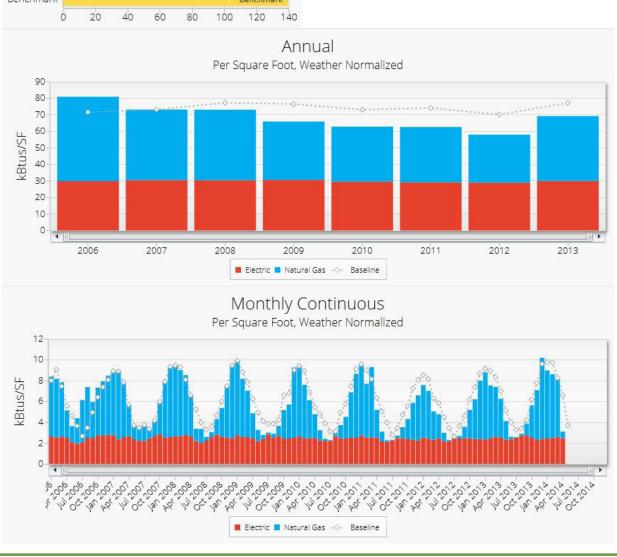
The College's Main Building EUI for April 2013-March 2014 was 71.17 kBtu/SF/year. The building is currently performing at about half of the Code Benchmark, or the energy that a similar building built to current code would be expected to use. Compared to a 2007 baseline, the building has also seen a 9.5% decrease in total consumption when normalized for weather and square feet, translating to a 28% decrease in annual energy expenditures. However, while annual energy consumption had steadily decreased since 2007, use in 2013 shot up again to above 2009 levels, even when accounting for weather. Electricity use has remained relatively stable over the time period, while natural gas use has increased. SCTCC may wish to revisit HVAC and lighting strategies to reduce its total energy consumption and cost.

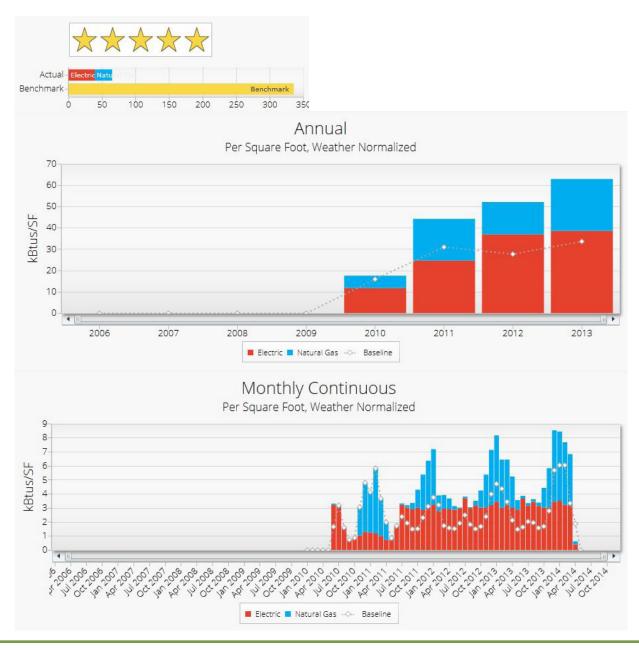
The Health Sciences Energy Use Intensity (EUI) for April 2013-March 2014 was 64.88 kBtu/SF/year. The building is currently performing much lower than the Code Benchmark, likely because the space is listed as "College Laboratory," a high-energy use more typical of chemistry labs with high ventilation requirements than the types of labs in this building, which are likely used in a manner more similar to classrooms. Still, 65 is low for a health-related use. Compared to a 2010-2011 baseline, the building has seen a 77% increase in total consumption when normalized for weather and square feet, translating to a 117% increase in annual energy expenditures. However, due to the jump between Spring 2011 and

Fall 2011, it seems likely that there was a change in use during this time leading to the difference. However, total consumption has increased steadily over time, and closer analysis of energy consumption in this building is recommended.

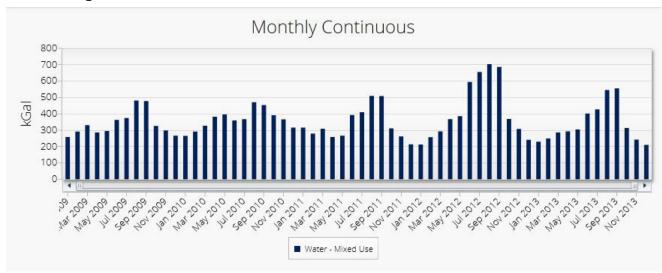
Main Building Water

Monthly campus water consumption data was recently added in to B3 Benchmarking. Water use peaks consistently over the summer months, suggesting that irrigation is major use of water on campus. Plantings with a no or low water requirement would be beneficial to reducing campus water consumption and cost, and should be considered as part of this master plan.

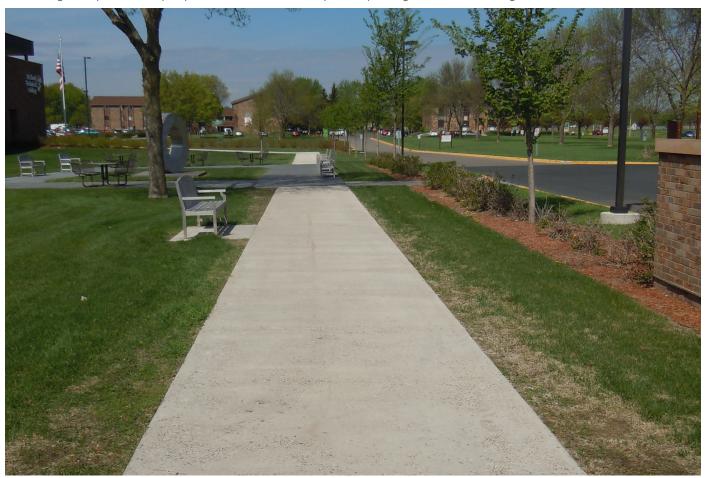
An existing example of a campus pedestrian route that incorporates plantings and site furnishings

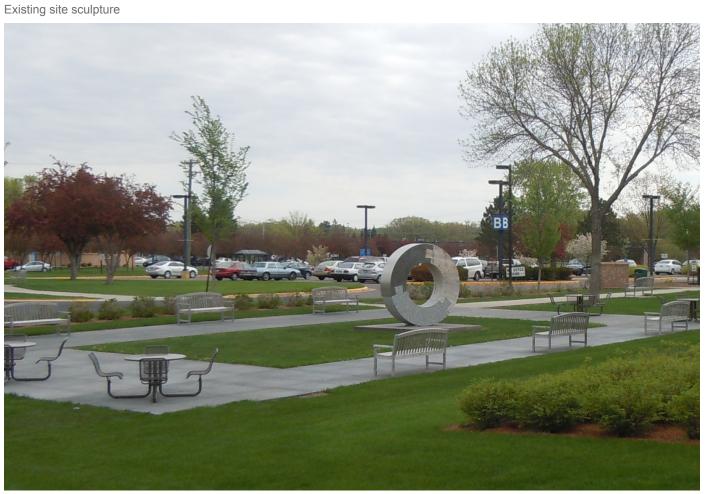
An existing parking area that incorporates plantings and a safe pedestrian route

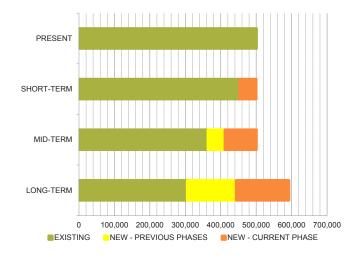
Graph - Potential campus square footage over time

It is recommended that SCTCC focus on reorganization and renovation of existing facilities, and the replacement of outdated facilities, through 2034 (the end of the midterm phase) to meet campus goals rather than the acquisition of new square footage. The following chart quantifies the total campus square footage by phase, and shows that the planned and proposed projects do not result in an overall increase until the long-term phase.

While the long-term phase of the plan does include property acquisition and a significant increase in total campus square footage, it should be noted that this is considered a long-term vision that is included to offer the campus flexibility to accommodate growth and change that may be projected to occur in 2035 and beyond.
